“To pouch or not to pouch?”

Enterocutaneous fistula & the effective use of the eakin Wound Pouch™

Fiona Le – Stomal Therapy Clinical Nurse Consultant

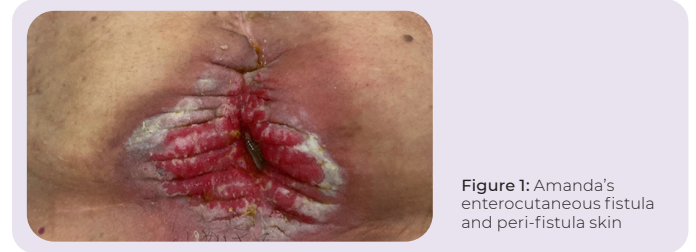
Figure 1: Amanda's enterocutaneous fistula and peri-fistula skin

Initially, Amanda's laparotomy site was covered with a transparent hydrocolloid dressing for protection. On day 5 post-operation, a transparent film with absorbent pad dressing was used as the abdominal wound site discharged moderate amounts of greenish fluid. However, a more absorbent dressing was applied the next day to Amanda's umbilical area as it was leaking large amounts of faecal fluid. The absorbent dressing was changed up to 5 times per day. Amanda had expressed her discomfort from frequent dressing change and complained of pain around the wound where her skin was inflamed, moist and excoriated (Figure 1).

The peri-fistula skin was at high risk of breakdown due to the proteolytic enzymes contained in small bowel effluent⁷. On day 12 post-operation, Amanda's CT scan had confirmed the development of ECF. Initially, a fistula separator and a negative pressure wound therapy (NPWT) vacuum-assisted closure (VAC) dressing were commenced as per Amanda's surgeon recommended. Indication for the use of NPWT for Amanda's fistula consisted of a high potential for spontaneous closure (especially those not matured) and no evidence of exposed intestine or other internal organs³. However, Amanda was unable to tolerate the pain which caused by the pressure from the NPWT device within an hour of application despite the pressure of therapy was set on a low intensity of 75 mmHg. In addition, the VAC dressing was leaking from the large volume of faecal fluids from Amanda's ECF. High output ECF which located at the base of an abdominal wound could present complex containment problem³.

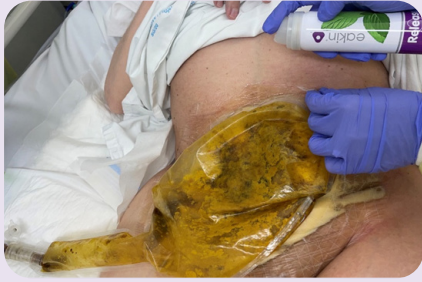
STEP 1:

Remove old eakin Wound Pouch™ with eakin® Release adhesive remover (Figure 2).

Figure 2: Wound pouch removal

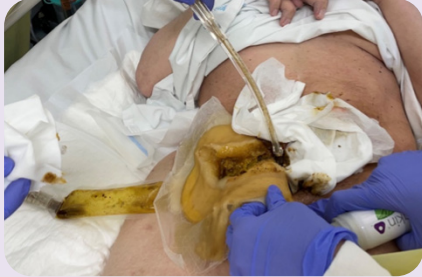
STEP 2:

Clean fistula and peri-fistula skin with warm water and suction the faecal output with Yankauer suction tip (Figure 3). Dry and apply barrier wipes around peri-fistula skin for protection.

Figure 3: Fistula and peri-fistula skin's cleaning procedure

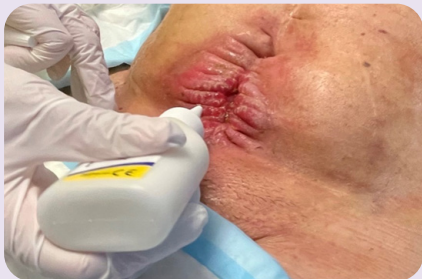
STEP 3:

Apply stoma powder around peri-fistula skin if excoriated (Figure 4)

Figure 4: Welland stoma powder application

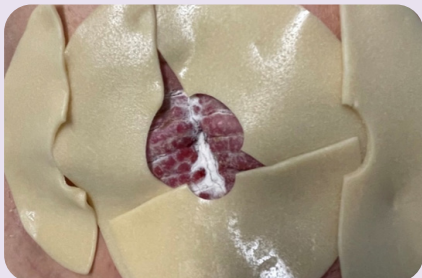
STEP 4:

Apply large eakin® Cohesive® seal on peri-fistula skin and at the abdominal crease area

Figure 5: eakin® seal's application

The dressing procedure for Amanda involved the application of large eakin **Cohesive**® seals to protect her peri-fistula skin and the application of the eakin Wound Pouch™ to contain the fistula effluent and ensure correct fistula output measurement. The large eakin **Cohesive**® seal were applied around Amanda's peri-fistula skin and the abdominal creases (Figure 5) to protect her skin, increase pouch wear time and prevent leakage⁷. The large eakin **Cohesive**® seal was chosen as it was able to cover a large area of peri-fistula skin, used on complex skin problems and uneven skin surfaces. The large eakin **Cohesive**® seal could also absorb the moisture from the peri-fistula skin and protect it from further moisture related skin damage⁷.

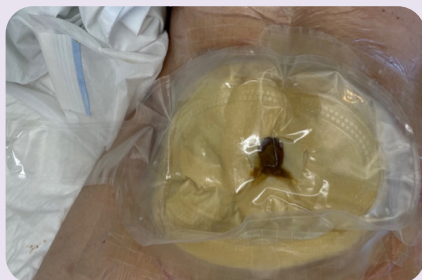
STEP 5:

Cut eakin Wound Pouch™ into the correct wound size and apply it horizontally. Connect eakin Wound Pouch™ to the free drainage bag (Figure 6)

Figure 6: eakin Wound Pouch™ application

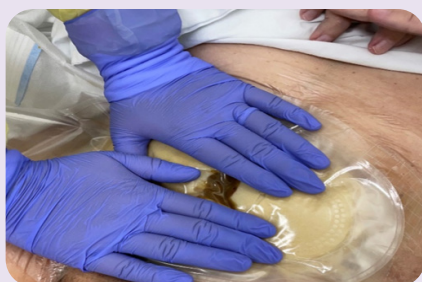
STEP 6:

Place both hands on the eakin Wound Pouch™ for approximately 5 minutes to enhance a longer adhesion (Figure 7)

Figure 7: eakin Wound Pouch™
